# BULLSEYE CO<sub>2</sub> Leak Detector

## **Finding Tough A/C Leaks BULLSEYE Style**

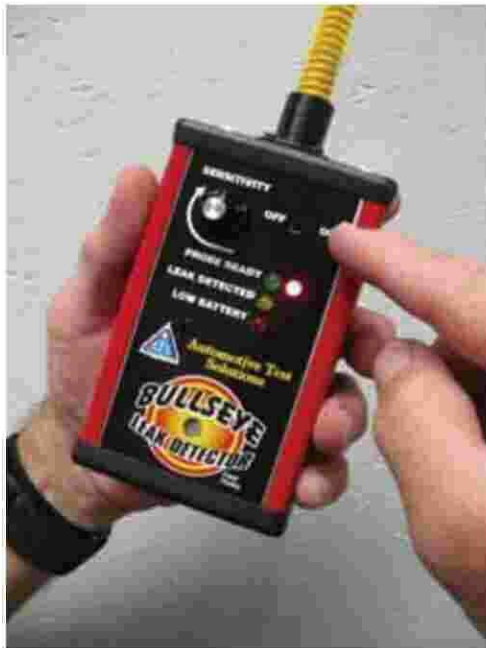
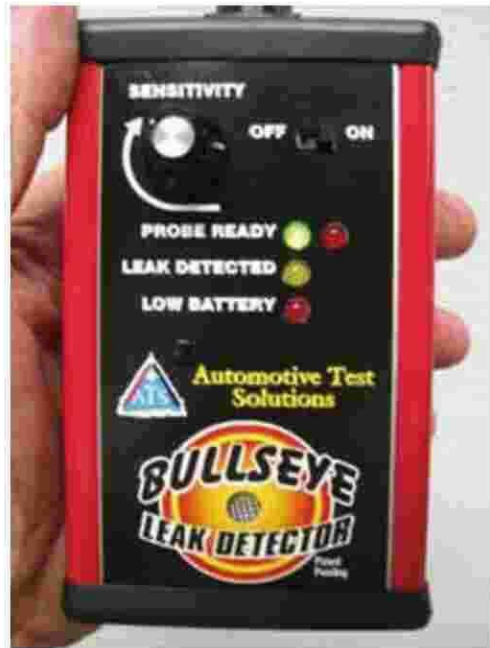
**Step 1.** Remove electronic leak detector from kit and turn on unit, allow unit to warm up the CO<sub>2</sub> sensor tip. When unit is ready the red light will shut off and the green ready light will turn on, this will take about 90 seconds. For best results the leak detector CO<sub>2</sub> sensor should be allowed to fully warm up for about 5 minutes.

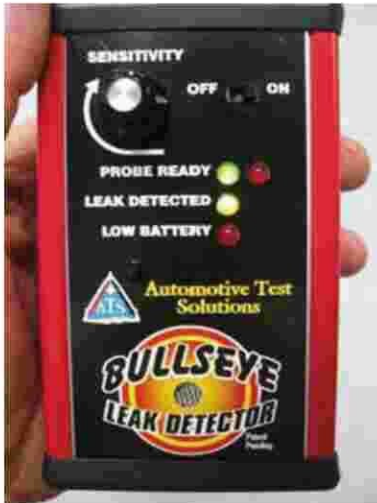
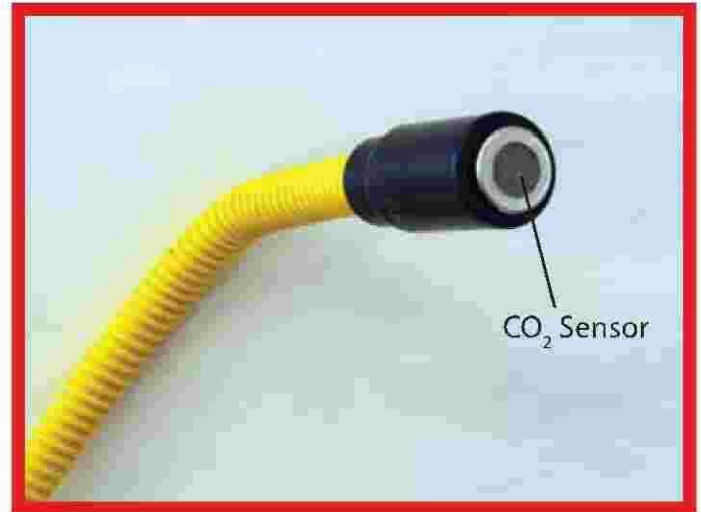
**Step 3.** Using the electronic leak detector go around the system to identify the leak site area. While moving the CO<sub>2</sub> probe tip around the system it is best to keep the CO<sub>2</sub> sensor face perpendicular to the surface being tested. **Note:** If tip is bumped against the surface being tested the detector may momentarily go off, this false alert will go off right away. If the leak detector senses CO<sub>2</sub> gas the alert will stay on for 10 to 40 seconds.

**Step 4.** When CO<sub>2</sub> gas is detected the yellow alert lamp is activated along with the audio alert (loud beeping noise). Once the detector has sensed CO<sub>2</sub> the alerts will continue for about 10 to 40 seconds;

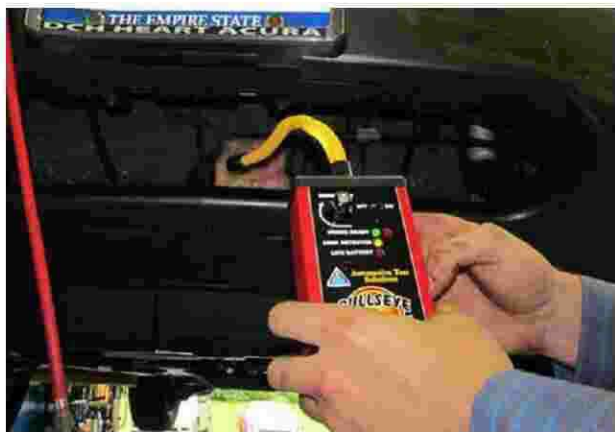
Figure 1

We recovered and evacuated the system and used the ATS BullsEye system, pressuring the A/C system with CO2. The CO2 molecule is smaller and more easily passes through small holes, making it easier to detect. Using the special leak detector that comes with the kit, we located the area of the leak in the vehicle's condenser (Figure 1). To confirm the small leak, we sprayed the BullsEye foam on the area where the BullsEye detector had triggered. As you can see (Figure 2), the pink foam (area of no leak) reacts with the CO2 and turns yellow, confirming the leak. A new condenser and receiver drier (one complete unit) later, and this customer's problem was solved!

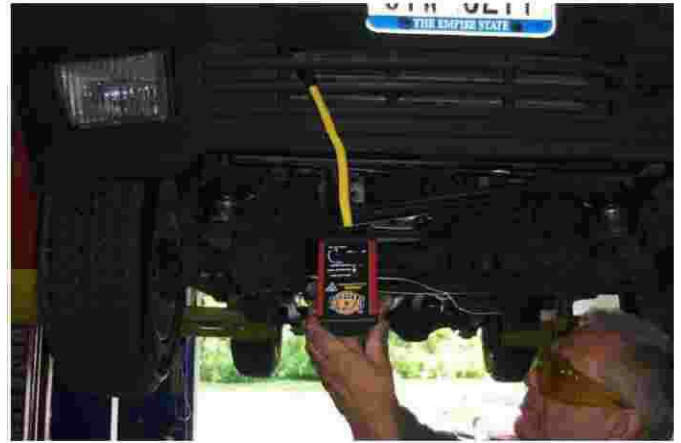
Figure 3

This Land Rover had a leaking AC System that was a breeze to find with the BullsEye Leak Detector. Since this vehicle came from another shop that had already looked for a leak we did not waste any time leak testing with dye or any other system except for the BullsEye. As you can see in the picture (Fig. 3) Jimmy is locating the area of the leak with the BullsEye CO2 detector. When the detector located the area I sprayed on the foam. There was no question where the leak was coming from. Take a look at (Fig. 4 & 5) the foam at the area of the leak turned pink. We returned the vehicle to the shop where they replaced the condenser, receiver drier and charged the system which fixed the vehicle.
